**Flood Control Project Maintenance
Levee Inspections**

Fall 2013 Levee Maintenance Deficiency Summary Report

Sacramento River Basin

Sutter Maintenance Yard Maintenance Area 0013

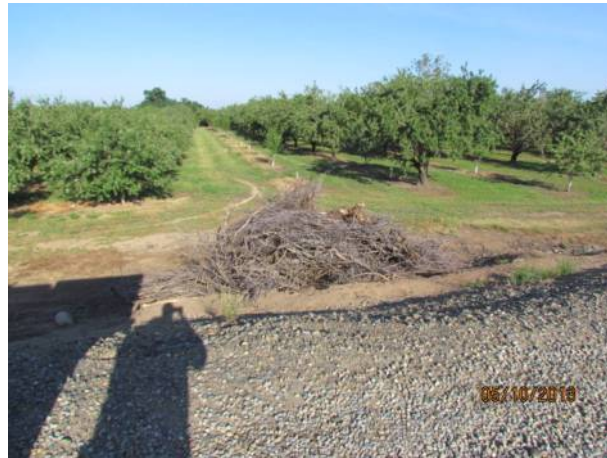
Levee Mile Report Line	30
Start Levee Mile	1.62
End Levee Mile	1.62
Location	Land Side
Category	Supplemental
Item	DWR UCIP Field Study

30	1.62	1.62	Supplemental	DWR UCIP Field Study	LS	U En	Inspector Comments: FS_ID:5941 EP_NO: N/A Repair Type: Urgent Crossing Status: Found UCIP Comments: Pipe collapse on waterside 10 feet of toe, needs repair. From WS, sediment is visible inside pipe. FIELD_STRUCT_DESC: 36 inch irrigation corrugated metal pipe through the levee, 7.8 feet below crown. Slide gate in corrugated metal pipe riser on the waterward slope. Concrete "U" headwalls on both ends (USACE-1962) This entry matches the Drainage or Irrigation Structure referenced in O&M manual (HLM 1.62). FS Date: 4/17/2012	39.576883 ° -121.702770 °	39.576883 ° -121.702770 °	42 Y
----	------	------	--------------	-------------------------	----	---------	--	------------------------------	------------------------------	---------

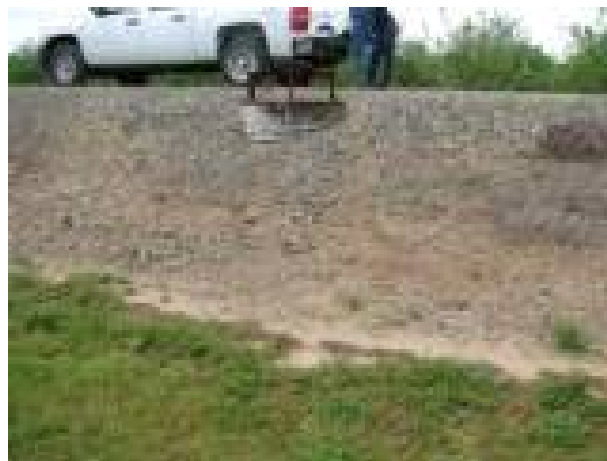
Levee Mile Report Line	45
Start Levee Mile	1.69
End Levee Mile	1.69
Location	Land Side
Category	Supplemental
Item	DWR UCIP Field Study

45	1.69	1.69	Supplemental	DWR UCIP Field Study	LS	M En	Inspector Comments: FS_ID:3266 EP_NO: N/A Repair Type: Non-Urgent Crossing Status: Found UCIP Comments: Pipe has 4" pipe inside blocking Positive closure/ notify land ownerto remove prior to flood season. FIELD_STRUCT_DESC: 24-inch corrugated metal irrigation pipe through the levee, 7.6 feet below the crown. Slide gate in corrugated metal pipe riser on the waterward slope. Concrete headwall on the landward side. 36-inch concrete standpipe in the channel with 2 piles to deflect debris (USACE-1960). This entry matches the Drainage or Irrigation Structure referenced in O&M manual (HLM 1.69). FS Date: 4/18/2012 10:09:00 AM	39.575816 ° -121.702897 °	39.575816 ° -121.702897 °	57 Y
----	------	------	--------------	-------------------------	----	---------	---	------------------------------	------------------------------	---------

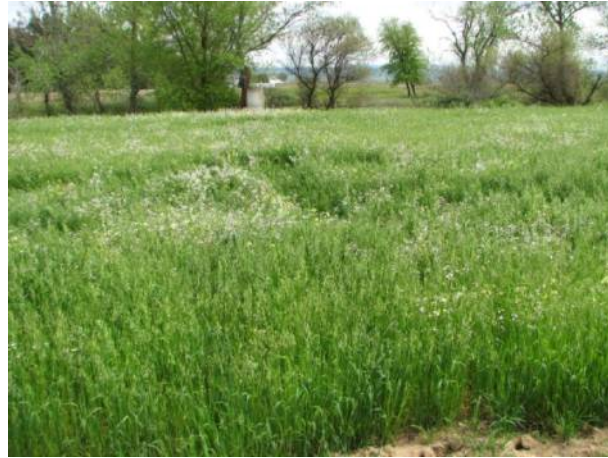
Levee Mile Report Line	58
Start Levee Mile	2.35
End Levee Mile	2.35
Location	Land Side
Category	Supplemental
Item	DWR UCIP Field Study
Apr 2012 - Stand pipe present on WS near main channel.	
UCIP_68.jpg

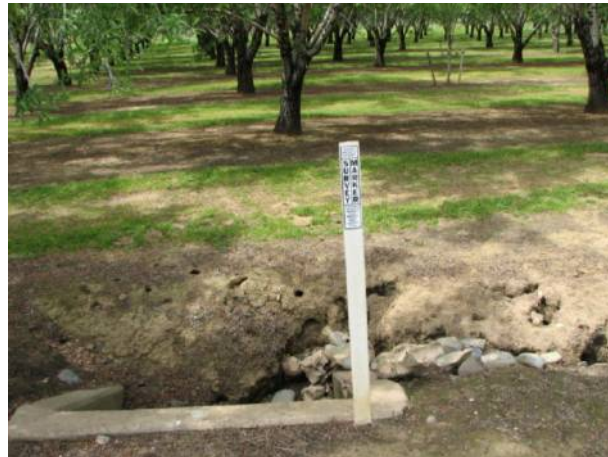
Levee Mile Report Line	85
Start Levee Mile	3.10
End Levee Mile	3.10
Location	Land Side
Category	Supplemental
Item	DWR UCIP Field Study
LS view of crossing. LS floor is higher than pipe invert.	
UCIP_9693.jpg

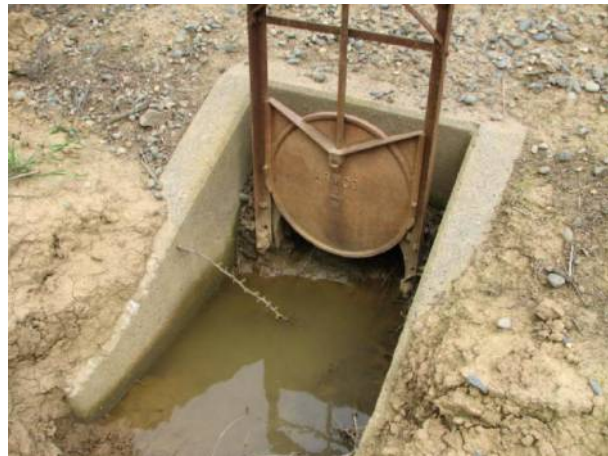
Levee Mile Report Line	86
Start Levee Mile	3.29
End Levee Mile	3.29
Location	Land Side
Category	Supplemental
Item	DWR UCIP Field Study
Apr 2012 - Gate valve on LS. Stem of valve is bent.	
UCIP_58.jpg

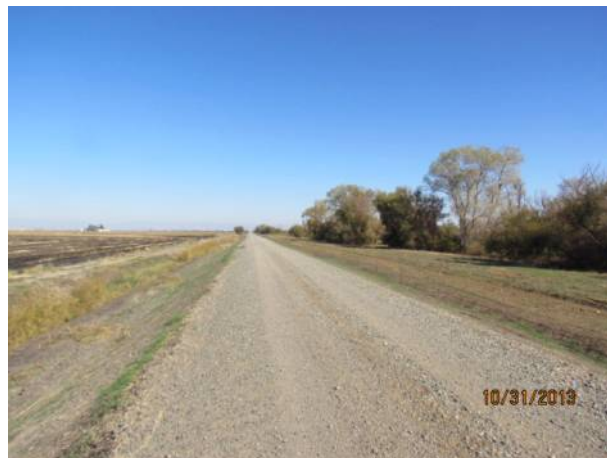
Levee Mile Report Line	304
Start Levee Mile	15.06
End Levee Mile	15.06
Location	Land Side
Category	Earthen Levee
Item	Vegetation

View of the burned and dragged slopes.
